REPORT ON
MITHI RIVER WATER POLLUTION
AND
RECOMMENDATIONS FOR ITS CONTROL

MAHARASHTRA POLLUTION CONTROL BOARD

KLEAN ENVIRONMENTAL CONSULTANTS PVT. LTD.,
ENVIRONMENTAL ENGINEERS, SCIENTISTS & PLANNERS

Ref.No.0407/MPCB Mithi River Survey/ 109

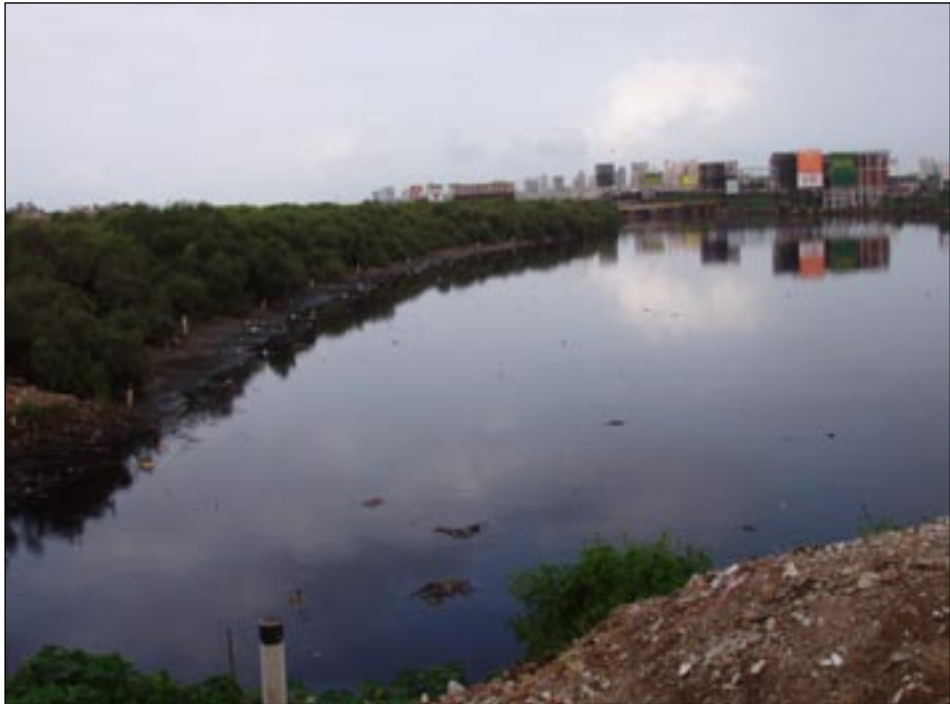
| 20) Mahim Creek | This area is surrounded by residential areas of Police colony, Fisherman colony and many slums surrounded the river. The span from Mahim creek to Dharavi has a very thick mangroves and area includes Salim Ali Bird sanctuary. |

03 Mahim Creek from Dharavi side

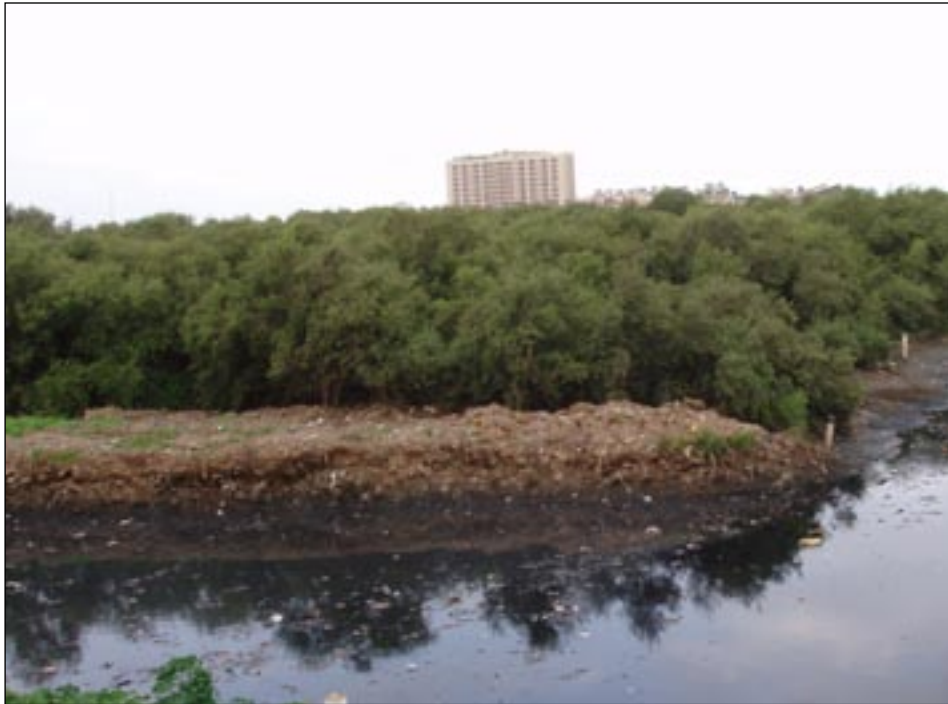
04 Mangrove at Mahim creek

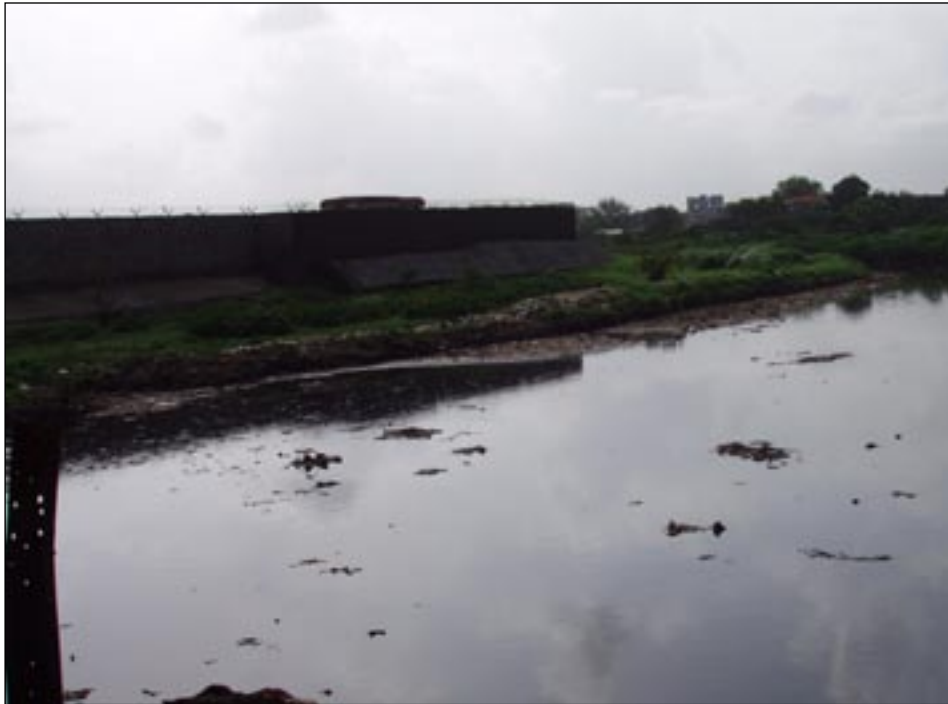
10 Mithi River near Airport - I

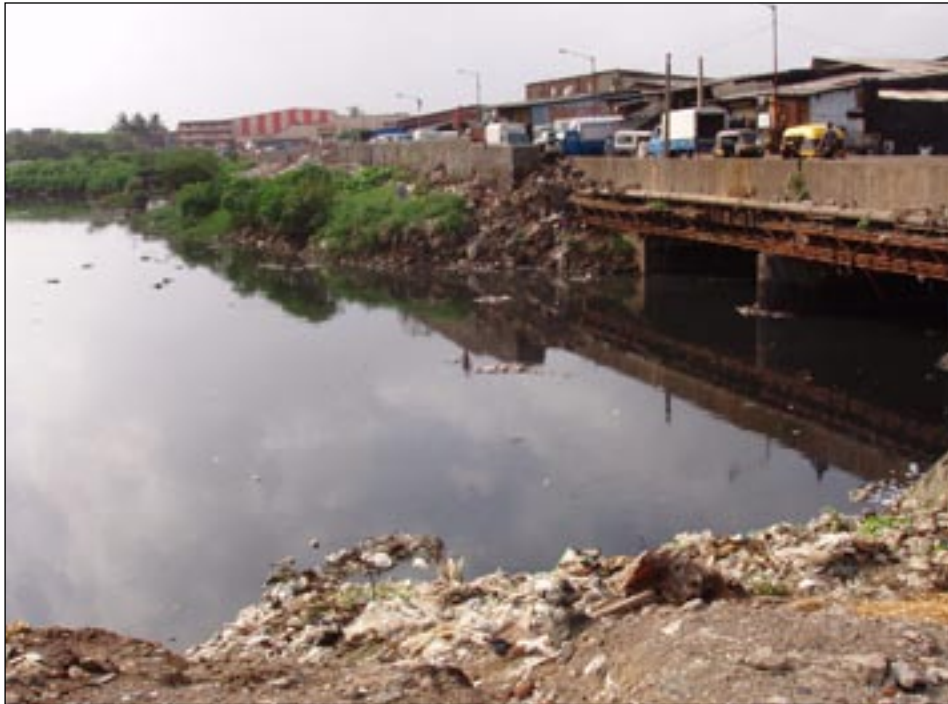
11 Mithi River near Airport - II

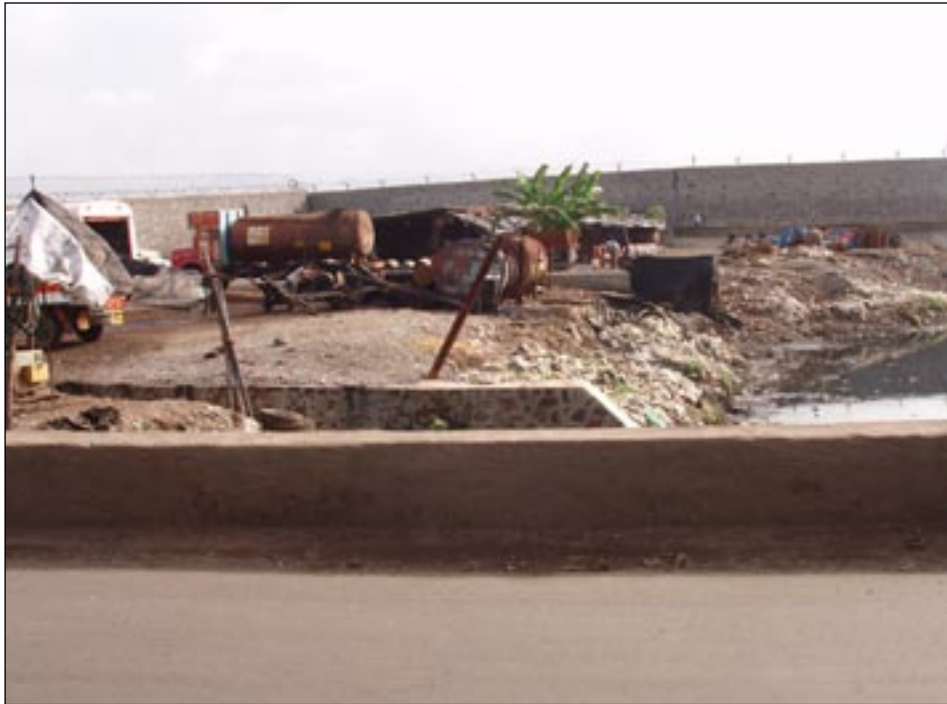
| 10) | L.B.S. Marg before Airport | This sampling point has maximum industrial activity indicating 40 to 50 Oil Refiners and other recyclers. |

12 Oil Industry at Old Airport Road

- 2) Immediately stop all the unauthorized industries which includes scrap dealers, scrap recyclers, waste oil recyclers etc. These industries contribute industrial waste, hazardous waste as well as sludge.

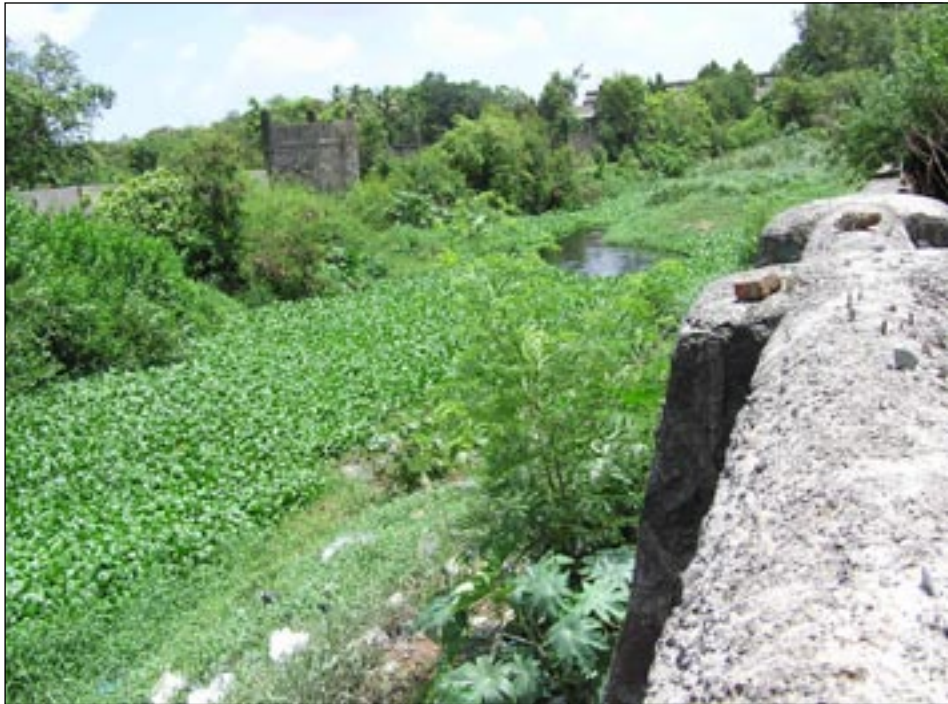
7)	Behind Samhita Complex Safed Pool.	This spot was surrounded by industrial are which has organized industries with probably small quantity discharge.

15 Samhita Complex, Andheri Kurla Road, Safed Pool - Note growth of Hyacinth and other vegetation.

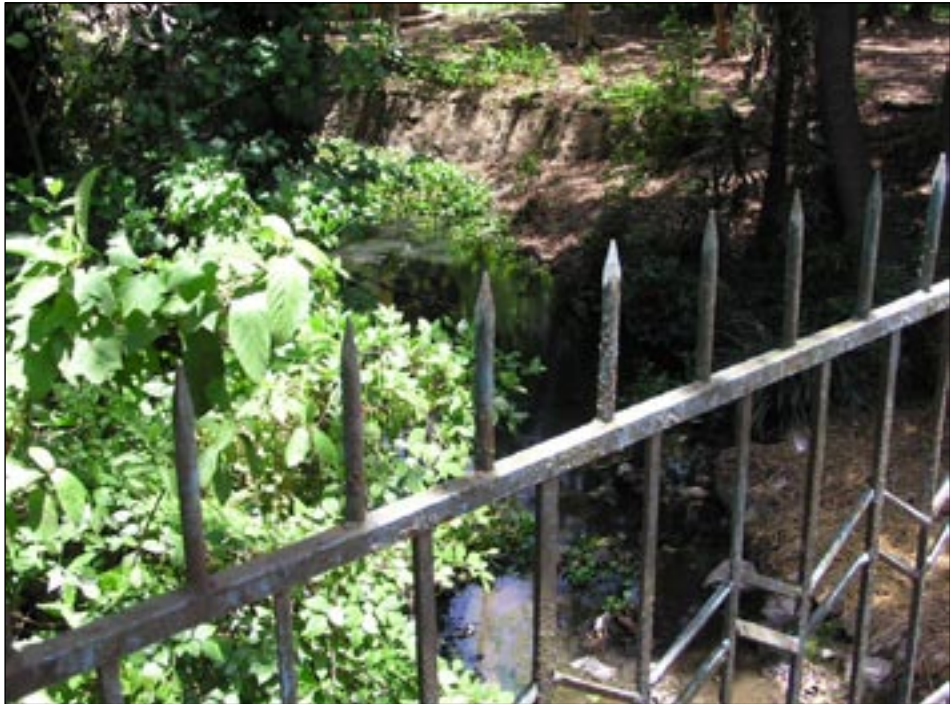
18 Powai Lake Overflow near Ambedkar Garden.
