1. The Members of Committee visited Airoli site on 15/4/2005 with Holding Pond as the Centre of the Project in question. Frontage of Sectors 13, 15, 17 & 18 (STP) were covered during the visit. Following observations were made by the Committee during the visit.

4.5 Minutes of the site meeting of the Committee on 9/5/05 at Airoli site:

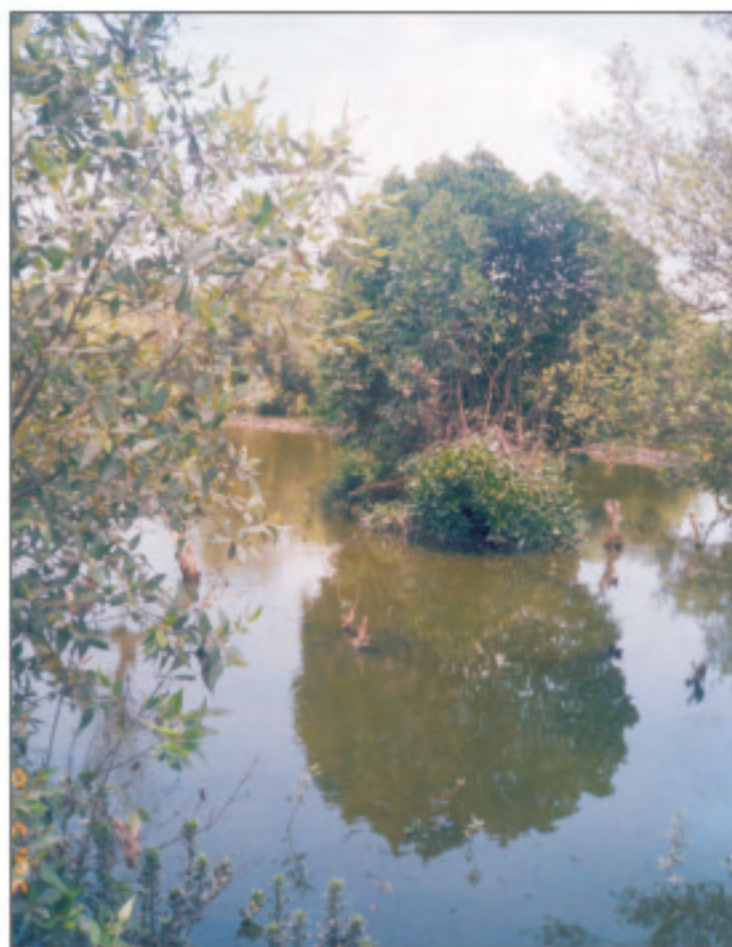
Fig. 1. A lone *Rhizophora mucronata* thicket in a fishing pond where other mangroves have been harvested to create the pond

7. Small-time fishing appeared to be in progress in places, where earthen-bunds have been erected to store creek water into small ponds. Small huts were present on the bunds, mostly to function as shelters for fishermen. The bunds have obstructed free flow of water in mangrove areas. It is reported that the fishing activity is illegal and encroachment by fishermen unauthorized.

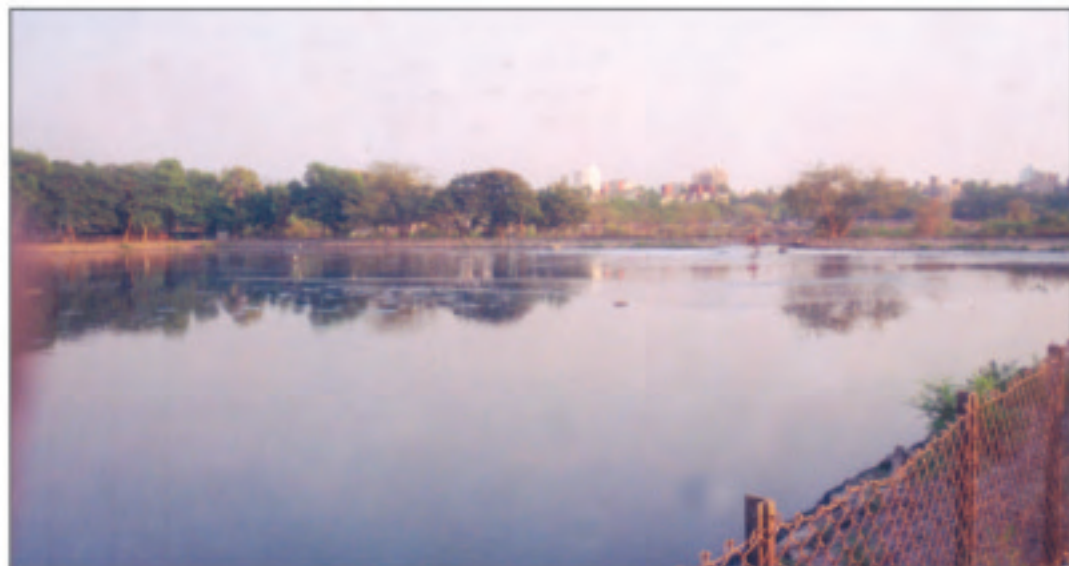
None of the aerators was functioning. One had been removed, two others were in precarious conditions, tilted and one-side-in-water position and the fourth one was reportedly under servicing! As a result of non-functioning of any of the aerators, the sewage water being pumped into the aerator lagoon, was totally untreated. This untreated water was flowing directly into the creek branch. No sewage water was flowing into oxidation pond either.

Fig. 2. Poorly maintained STP at Airoli

Abundant growth of blue-greens on the margins of the aerator lagoon and on the objects like the unused aerator, rope, etc., as also bubbles emerging from the bottom of the lagoon indicated high level eutrophication of water in the lagoon. After reaching the creek branch, the waste water was moving with tidal water. Almost 50 meter stretch of the creek stream, stretching on either side of the confluence with sewage water, was dirty gray in color and highly odorous, indicating that the sewage water had little change to drain into the Thane creek.

Apart from non-functioning of the aerators, the oxidation ponds were also not in use. Water was let off into the creek irrespective of tidal situation.

2. Mr Khan, Executive Engineer from NMMC informed that the two aerators which were not in operation during the visit of the Committee will start functioning from Wednesday i.e. 18th of May, 2005 and others will be re-installed as early as possible. Mr Patnigire, Dy. Commissioner, informed that the park beautification will be undertaken soon, though he could not specify the time frame. He informed that Rs.75 lakhs were earmarked for this purpose and passing of the budget was awaited. He also informed that, notices have been given to the operators of fish ponds, mainly on the ground of menace of mosquitoes breeding in the area. According to him, all the fishing ponds in the area are unauthorized but their removal may create law and order situation. He requested the Committee to take up the issue with Police Dept for extending required assistance, while carrying out removal of bunds. He assured that removal of debris and proper functioning of STP will be undertaken on priority.
