#### **4.4 Minutes of the Meeting held on 16/5/2005 at MPCB (HQ), Sion, Mumbai:**

## **OBSERVATIONS:**

### **5.1 HOLDING POND & AREA AROUND AT AIROLI :**

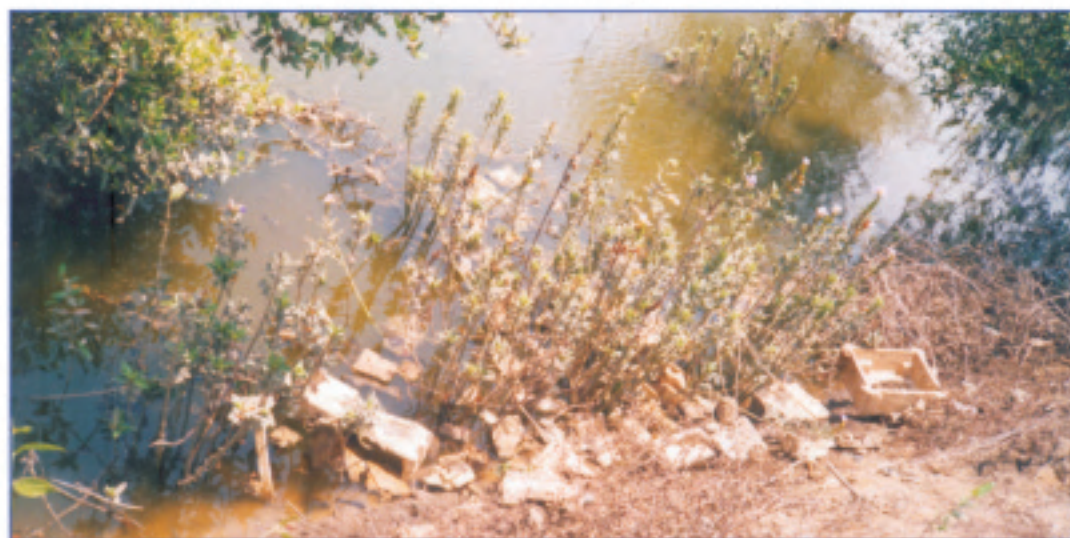
Solid waste from the neighborhood (mainly the hospital in this place) was dumped on roadside area of the pond. It was mainly the packaging material like thermocol, paper, cartons, etc., but glass (light tubes, bulbs, bottles) and plastics were also visible. Construction rubble was also present.

**Fig. 3. Solid waste dumped along the artificial fishing pond**

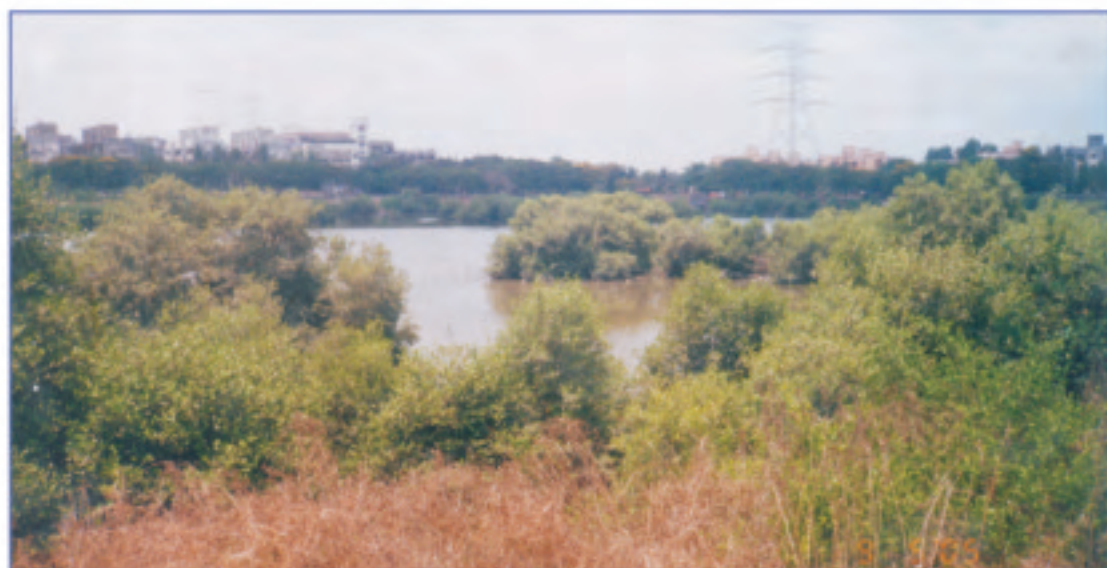
**Fig. 4. Holding pond at Airoli with Mangroves growing along the boundary**

- Along the fringes of the holding pond, the mangroves are in degraded condition.

The NMMC, with the help of expertise available from Forest Department as well as from other sources, should undertake a programme of protection and restoration of mangroves. Beautification plan should be considered for preservation and improvement of mangroves which are already in existence in the area. All along the boundary of the pond, wherever the mangroves are degraded, plantation of mangroves should be undertaken in which towards the water a row of *Rhizophora* should be planted. While plantation of mangroves, natural zoning of mangroves should be considered as a guideline.

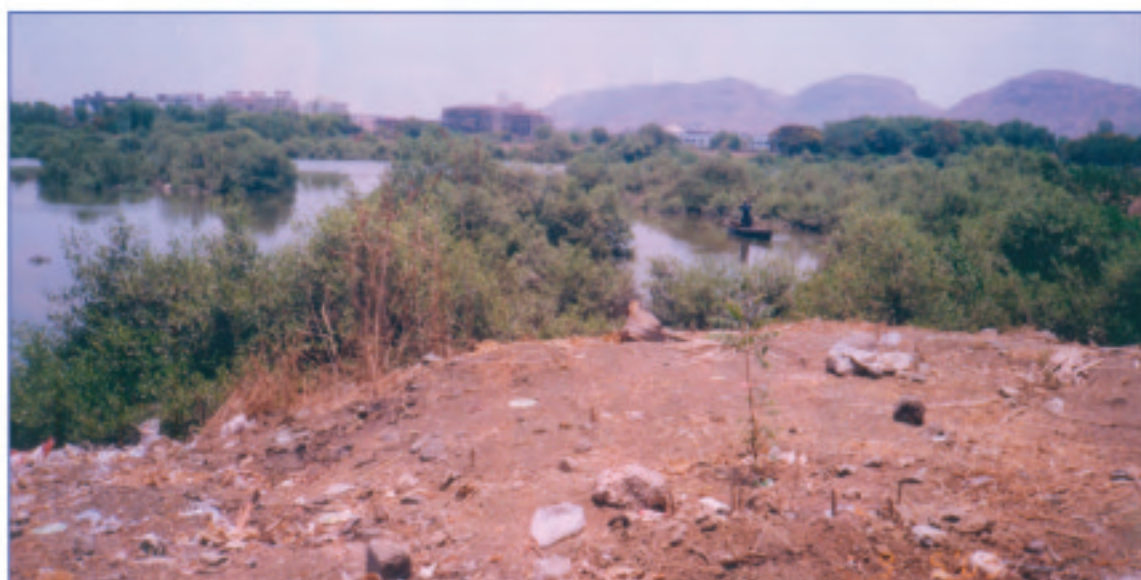
- Bank of the pond is covered with waste dumped, especially construction waste and domestic refuse. This is gradually reducing the area of the pond and increase in the land along the periphery of the pond.

**Fig.5. Dumping of refuse & municipal solid waste on the bank of Airoli holding pond**

NMMC should take immediate steps to stop dumping in that area and clean up the entire area of the existing debris and waste especially along the banks of the pond. This cleaning should be done to reach the original pitching of the bank.

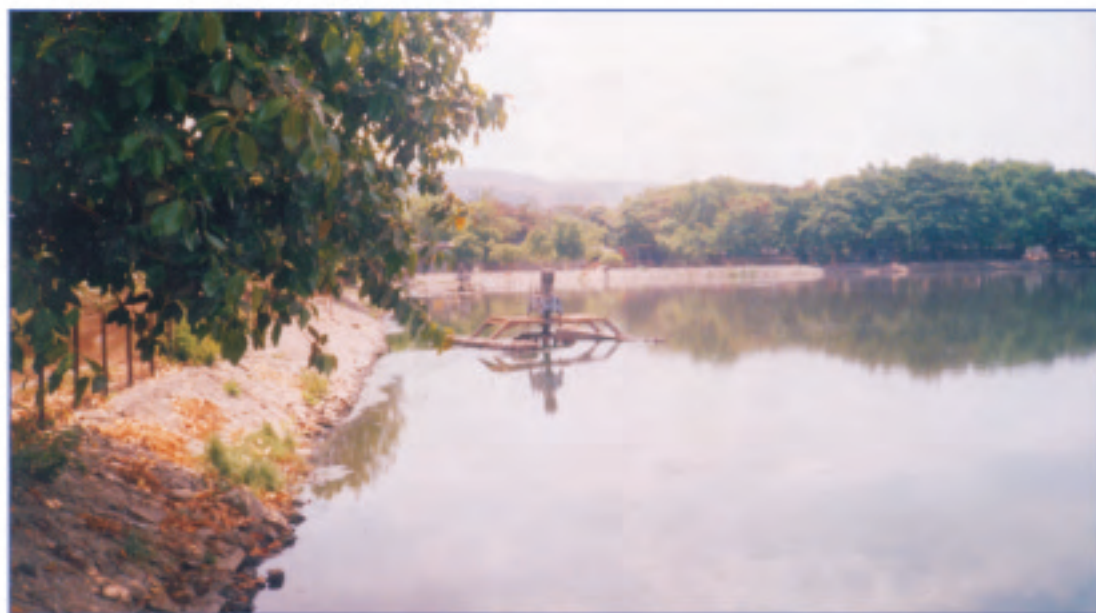
- The present condition and functioning of the STP is observed to be very poor. Substantial amount of sewage was found to be accumulated and heavily sedimented in the pond. The conditions are eutrophic as indicated by foul odour, presence of blue green algae and generation of bubbles rising from bottom of the pond. The sewage water is seen to be going into the creek without any treatment. The waste water will affect aquatic life. Proper operation and maintenance of STP is required to be done by the NMMC.

**Fig. 6. Non-functioning aerator at Airoli Sewage Treatment Plant**

1. Functioning of STP should be efficient and be done by technically competent personnel. The NMMC should device a monitoring mechanism to ensure efficient and round the clock functioning of STP as per guidelines issued by MPCB.
2. The aeration tank should be desilted. The silt removed should be disposed off in the area marked for solid waste disposal.
3. The disposal point for the treated waste water should be properly designed and located in consultation with expert agency such as NIO, Goa.
4. The sewage flow meters and energy consumption meters should be installed at STP. Proper record should be maintained. Monthly returns should be submitted to the MPCB.
5. All the equipment of STP, including the lining of the pond should be repaired and maintained properly.

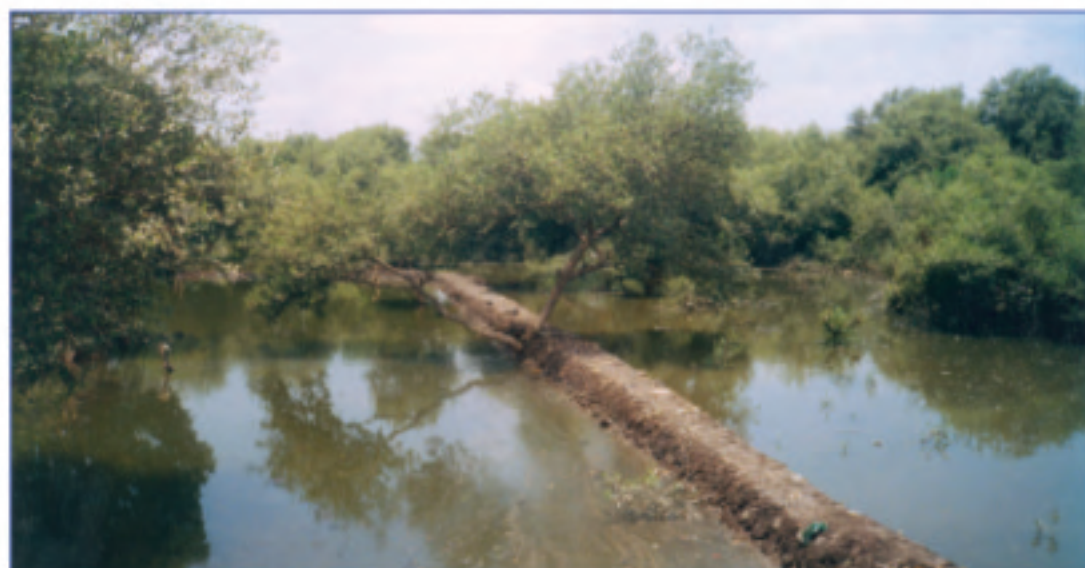
- There are several ponds (Some 60 odd as reported by locals) constructed across flow of tidal water in the mangrove area i.e. CRZ-I. All these ponds are reported to be illegal. Some of the tidal water flows into these ponds along with fish-fingerlings. Locals harvest these, after sometime. This fishing mechanism means that young, immature fishes are harvested and that fishes are not allowed to grow to their normal size. It is a fact that many of the fish species breed in mangrove areas. If the finger- lings are harvested in this way the fish population in the creek will be adversely affected. Whenever commercial fishing is done in the creek, it will also be adversely affected.

**Fig.7. Fishpond opposite to Burns Hospital, Airoli**

1. Since these fishing ponds are illegal, they should be dismantled immediately. The barren areas thus remaining behind should be opened, by digging trenches if necessary, for free movement of tidal water and be planted with the mangrove species that exist in the vicinity.
2. The NMMC authorities may explore the possibility of directing the traditional fishermen community to refer to the Supreme Court directive for organizing aquaculture parks. Feasibility of such parks should be checked by CZMA, before permitting the activity in Airoli.
