- 6.1.** In response to a letter from Hon'ble Shri Gajanan Kirtikar, M.L.A., Maharashtra, MPCB constituted a Committee of Experts to study the Airoli creek, Mangroves and holding pond environs and suggest an action plan for improvement of environment of that region.

6.2 RECOMMENDATIONS:

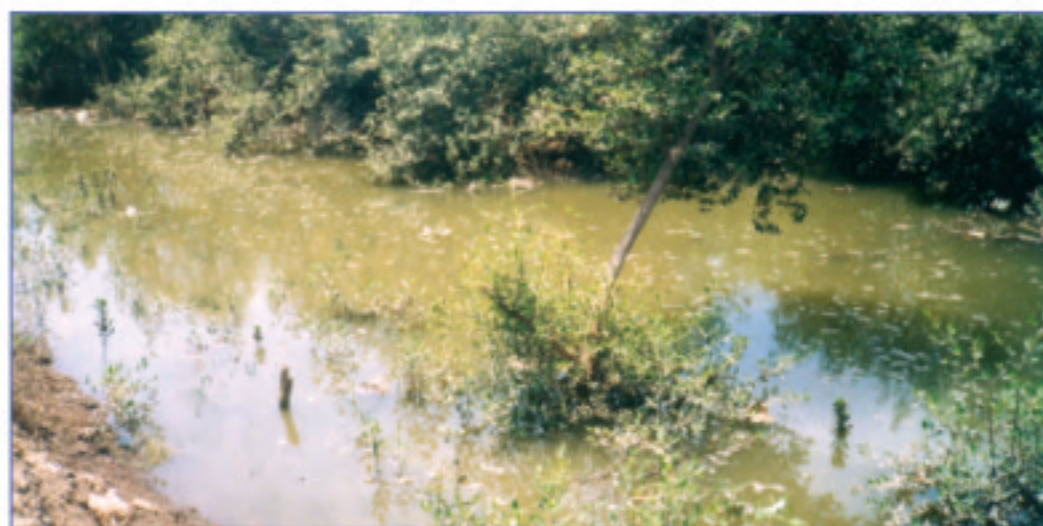
- Mangroves are presently in degraded form as seen from their height and canopy shapes. The diversity is good though *Rhizophora* species are near extinction. At some places, the degradation of mangroves like *Avicennia* has given way to noxious species like *Acanthus*. At the bottom of fishing ponds, the mangroves have been cut down as can be seen from the remnant stumps. The pond constructed for fishing has obstructed the flow of tidal water, resulting in destruction of mangroves.

Fig.8. Stagnated water in fishpond, bund on left foreground, stumps of harvested mangroves and seedlings of *Avicennia* are visible.

1. All the areas where mangroves are present i.e. in the creek region and in the holding pond region etc. should be effectively protected. Some important mangroves species like *Rhizophora*, which are on the verge of vanishing from the region, should be planted under expert advice.
2. The NMMC should take all possible steps for protecting the mangroves.

- 6.2.7 Illegal fishponds:** Since the fishing ponds are illegal, they should be dismantled immediately. The barren areas thus remaining behind should be opened, by making trenches if necessary, for free movement of tidal water and be planted with mangrove species that exist in the vicinity.

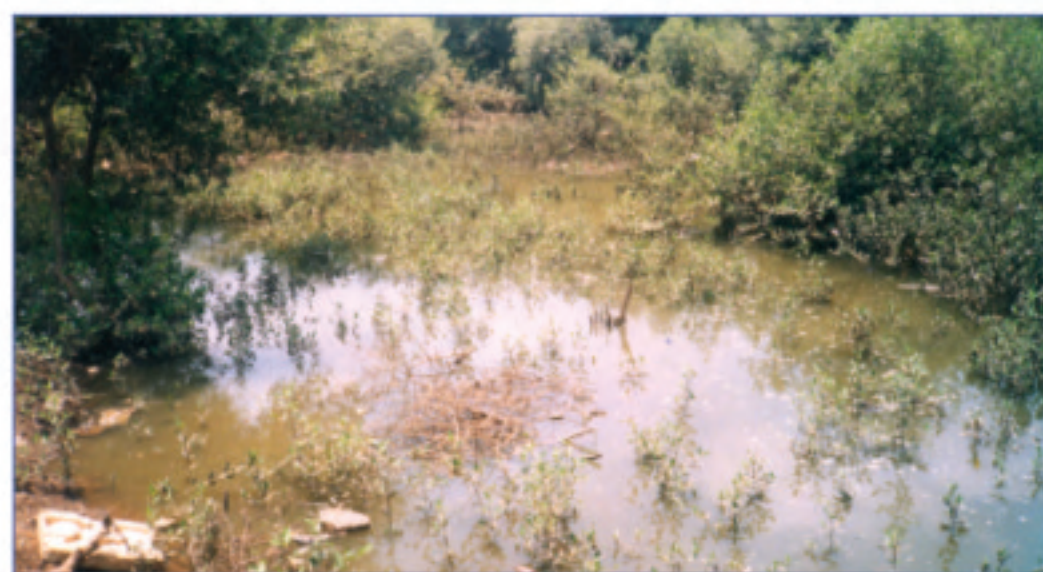
Fig. 9. Abundance of *Avicennia* seedlings promise regeneration of mangroves under protection.

- 6.2.3 Protection of Mangrove Areas:** The NMMC should take all possible steps for protecting the mangroves. All the areas where mangroves are present i.e. in the creek region and in the holding pond region, etc., should be effectively protected. Some important mangroves species like *Rhizophora*, which are on the verge of vanishing from the region, should be planted under expert advice.

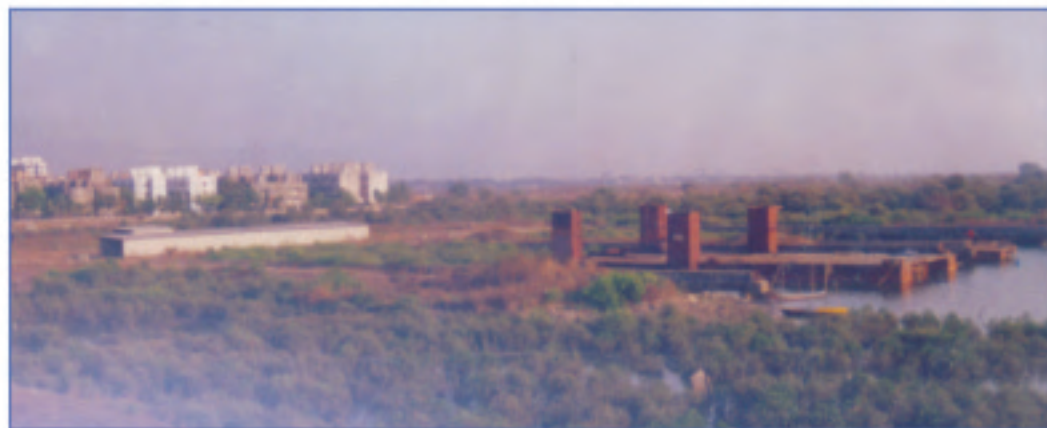
- A huge area of land that was reclaimed for storage of material for construction of the bridge appears to remain as such after completion of construction of the bridge. The area that appears as an abandoned plot is likely to be encroached upon in course of time.

Fig. 10. The abandoned jetty & the other structures that were used for construction of Airoli bridge

6.2.18 Removal of abandoned Jetty at Airoli Bridge: CIDCO should be directed to remove the shed and other material lying near the bridge/jetty and take steps to beautify the area/restore the area to its original shape in a time bound manner.

6.2.19 Restoration of Jetty site: After demolition of the existing unwanted structures at the above jetty site, the area above HTL should be developed into a park and area below the HTL should be planted with mangroves

1. The area should be developed into a park.
2. The area below the HTL falling in CRZ-I should be reserved for regeneration of mangroves and plantation of mangroves may also be undertaken in this area, as per expert advice.
3. The NMMC should involve Forest Deptt. or other concerned agencies for conservation and propagation of mangroves.
4. CIDCO should be directed to remove the shed and other material lying near the bridge/jetty and take steps to beautify the area/restore the area to its original shape in a time-bound manner.
5. Action Plan supported with Bar chart should be submitted by CIDCO and NMMC to MPCB for implementation of recommendations. CIDCO & NMMC should submit Progress report to MPCB on regular basis.
