REPORT ON
MITHI RIVER WATER POLLUTION
AND
RECOMMENDATIONS FOR ITS CONTROL

MAHARASHTRA POLLUTION CONTROL BOARD

KLEAN ENVIRONMENTAL CONSULTANTS PVT. LTD.,
ENVIRONMENTAL ENGINEERS, SCIENTISTS & PLANNERS

Ref.No.0407/MPCB Mithi River Survey/ 109

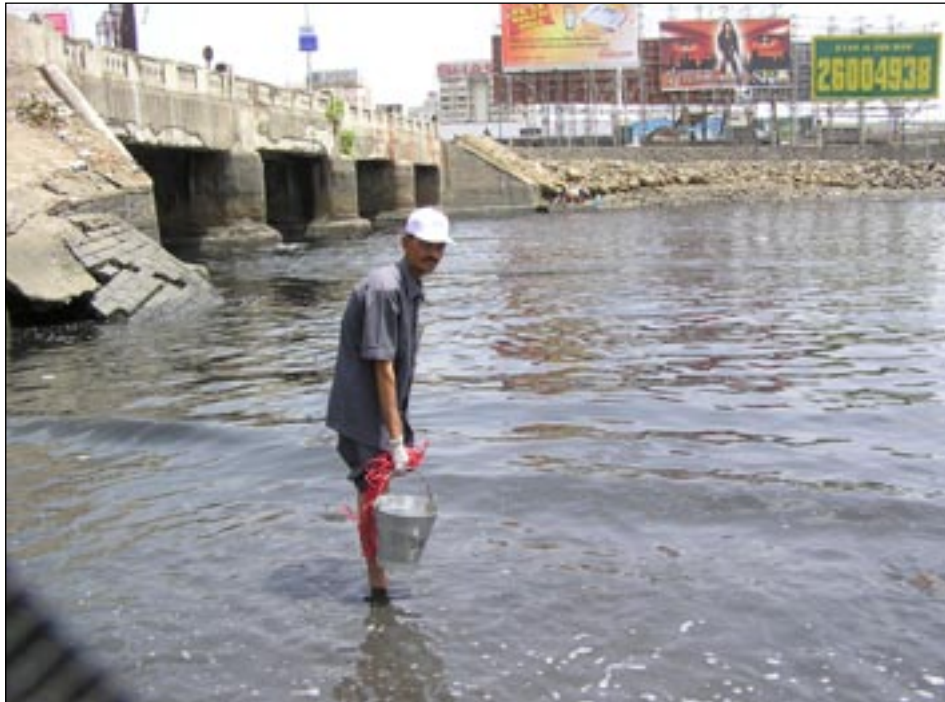
1. Mahim Bay, before Mithi river meets sea.

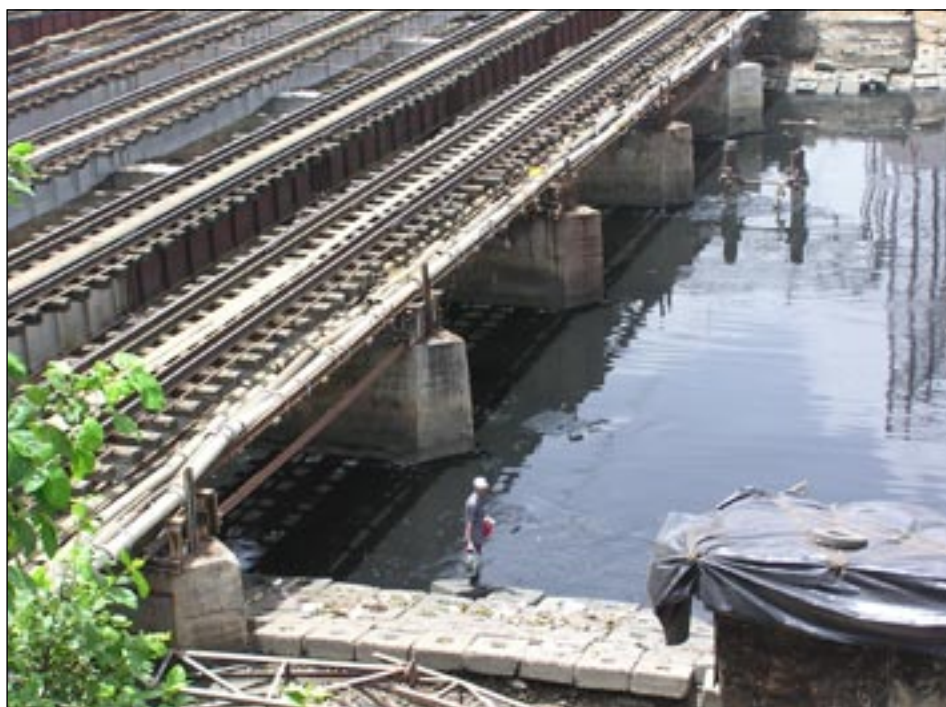
| 19) | Western Express Highway | The sample point under the Western Railway track indicated septic sewage by bad stink and at the same time since the sewage is mixed with sea water the odour of effluent increases due to chlorides. |

2. Under Western Express highway showing septic nature of Mithi River by it's black colour

- 1) Provide sewerage system on both the banks of the river so that the sewage is collected and treated at various locations. This includes existing sewage discharge drains provided by BMC

- 5) To improve the quality of water, sewage treatment plants are essential at various locations. The analysis report clearly indicates that the water after treatment can be reused in industry or for gardening. Both the banks of Mithi river can be planted with proper vegetation for beautification. In fact this will work as a natural eco-system to improve the quality of water and save cost of providing expensive treatment plants.

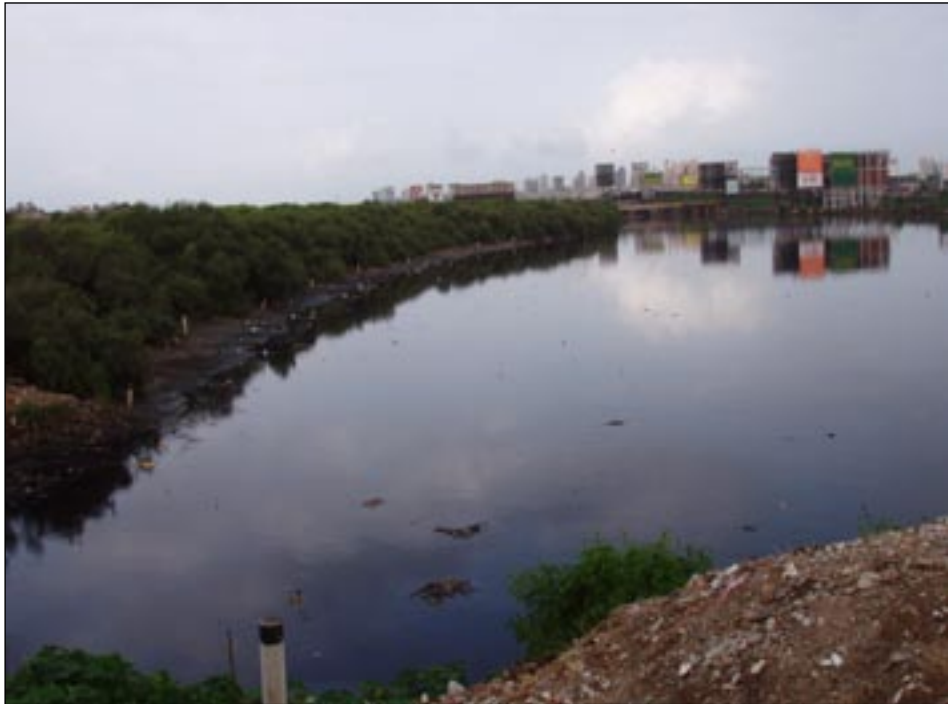
| 20) | Mahim Creek | This area is surrounded by residential areas of Police colony, Fisherman colony and many slums surrounded the river. The span from Mahim creek to Dharavi has a very thick mangroves and area includes Salim Ali Bird sanctuary. |

03 Mahim Creek from Dharavi side

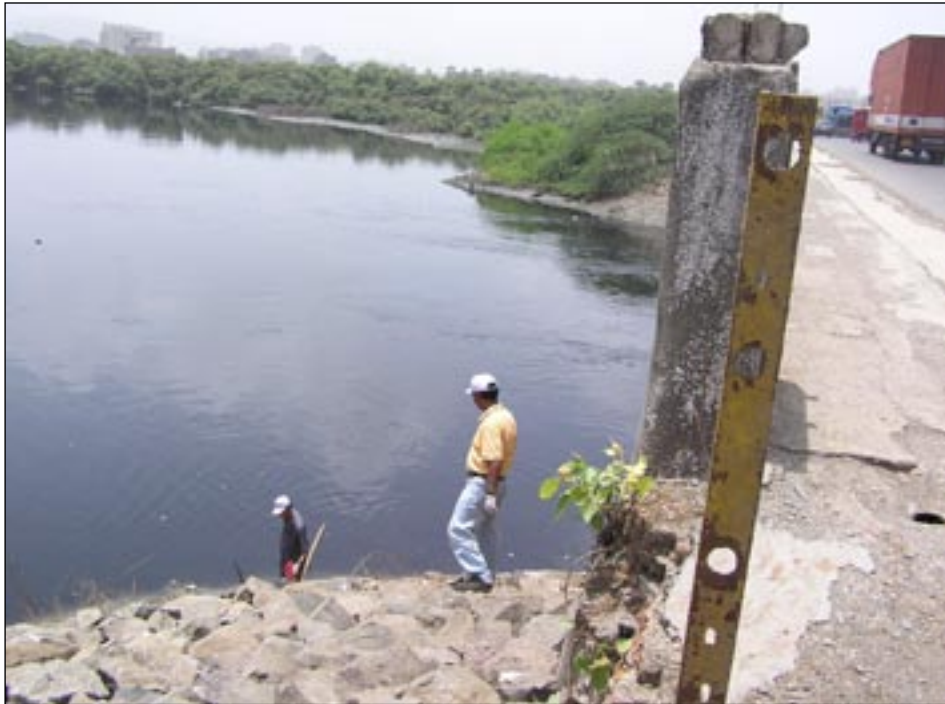
| 18) | Kalanagar Junction | Here river carries with discharges of various colonies, residential area of Dharavi etc. The effluent mixing of river water into sea is noticed at this point. |

05 Kalanagar Junction showing mangroves of “Salim Ali Bird Sanctuary”

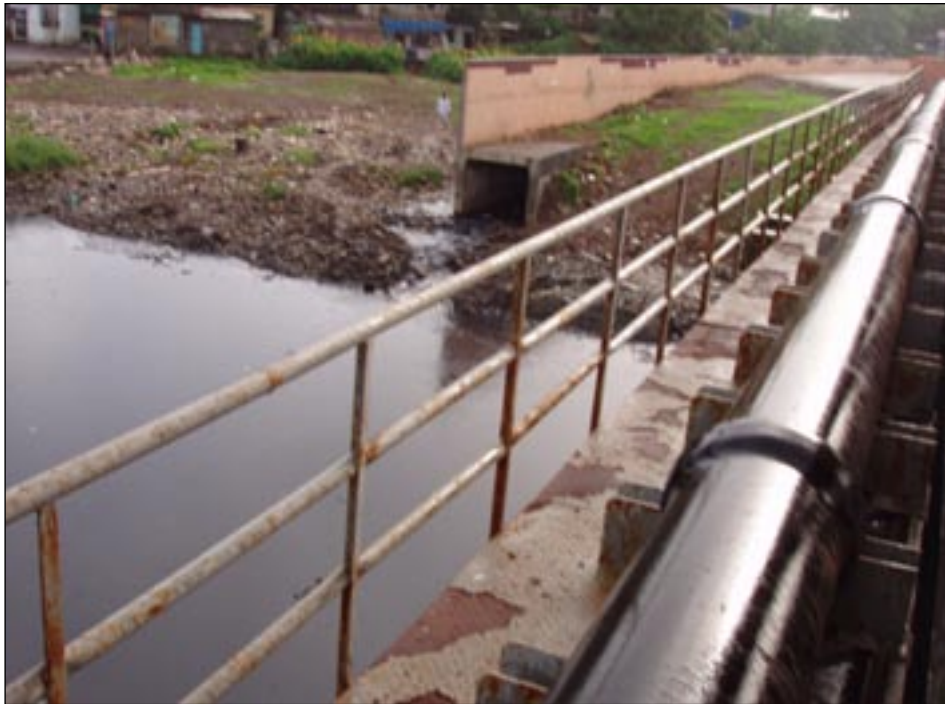
| 17) | Near Worckardt office Bandra Kurla Road | A 2m x 2m RCC drain discharges at this point into the river under the bridge. Due to this discharge the values of all the Parameters like Suspended solids, chlorides COD, BOD etc. shot-up. |

06 Sewer outlet near Wockhardt office

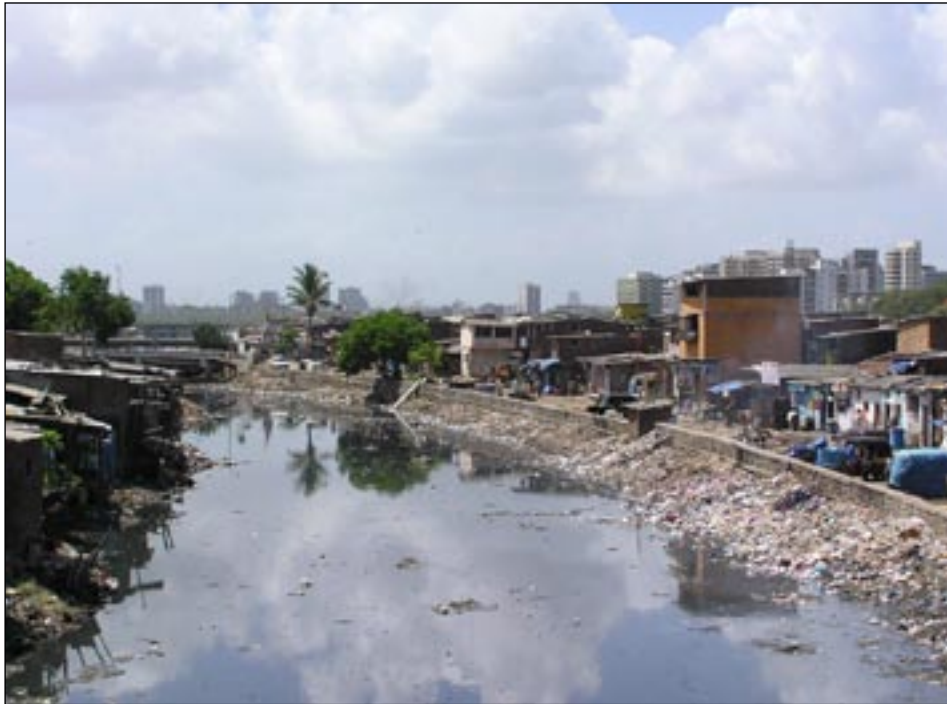
07 Bridge after taking left turn from HP Petrol Pump - Note the width of river.

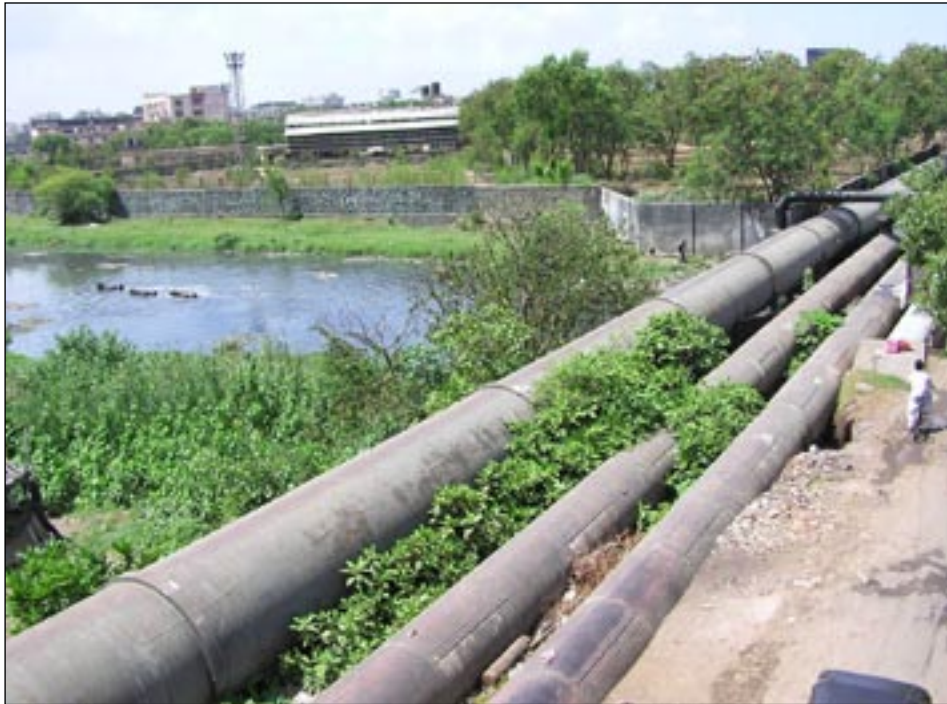
| 15) | Near Hyatt Hotel | This area is surrounded by properly designed residential complexes and apparently river carries no liquid effluent. The hyacinth grown in the bed is noticeable and water is used by resident for secondary purposes. No industrial activity in this sector. |

08 Vokala Pipeline near Hyatt Hotel - Buffaloes enjoying swim.

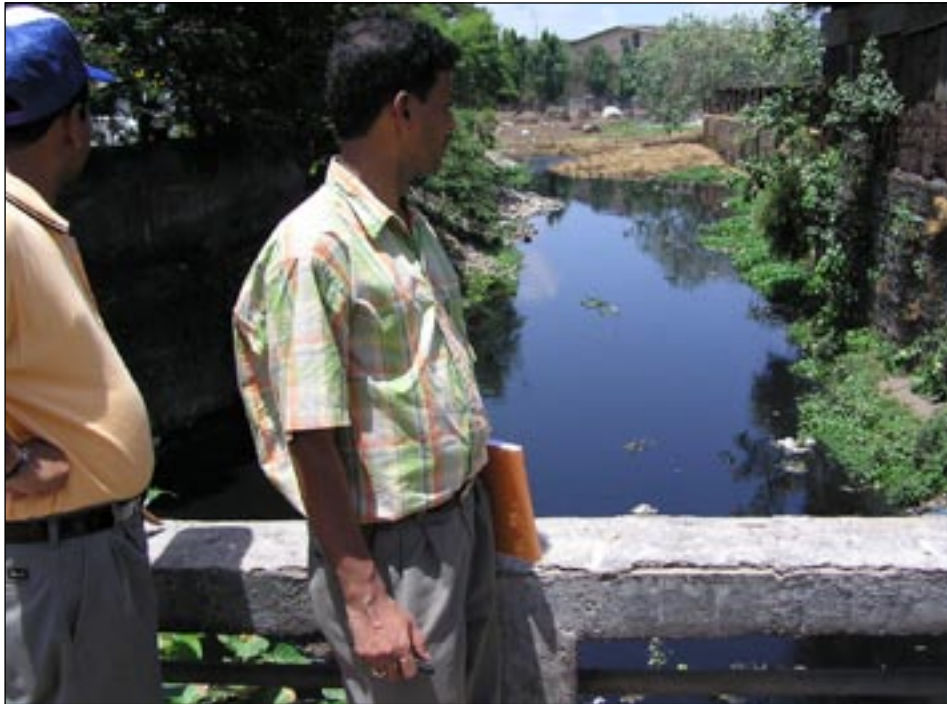
| 14) | CST Road, Kalina | This sampling point is surrounded by many small scale industries including Recyclers, Barrel cleaners, workshops and other units. This area has thick density of population. |

09 CST Road, Kalina - This is a highly polluted area and a heaven for recyclers.

- 2) Immediately stop all the unauthorized industries which includes scrap dealers, scrap recyclers, waste oil recyclers etc. These industries contribute industrial waste, hazardous waste as well as sludge.

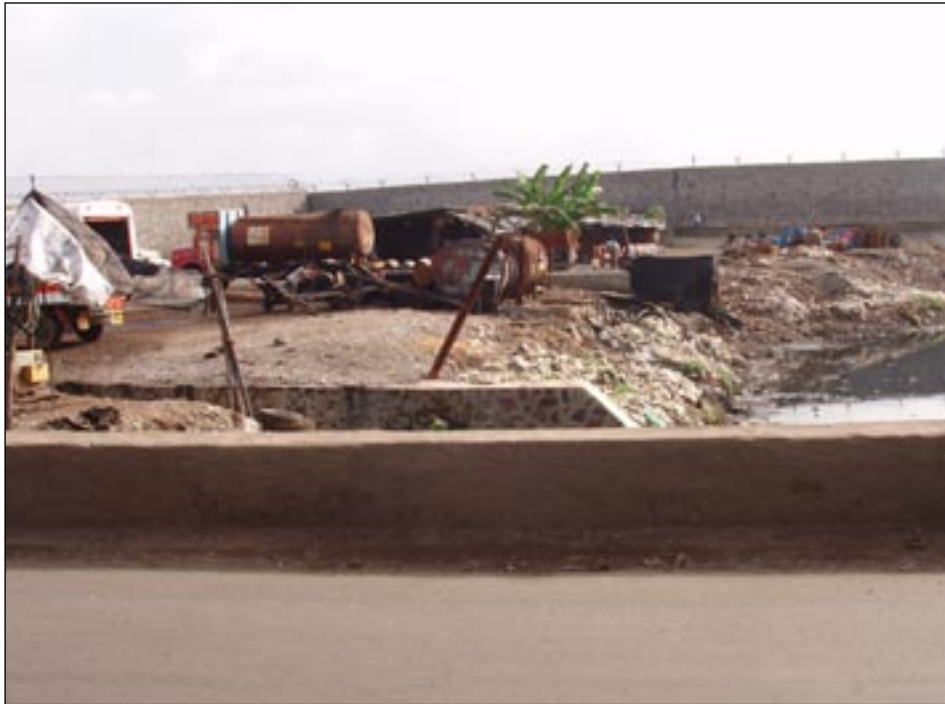
| 10) | L.B.S. Marg before Airport | This sampling point has maximum industrial activity indicating 40 to 50 Oil Refiners and other recyclers. |

12 Oil Industry at Old Airport Road

- (1) Immediate closure of all the unauthorized activities which discharge industrial effluents, sludge, oil and chemicals.
- (2) Provide proper garbage collection system to prevent citizens from dumping the same into the river.

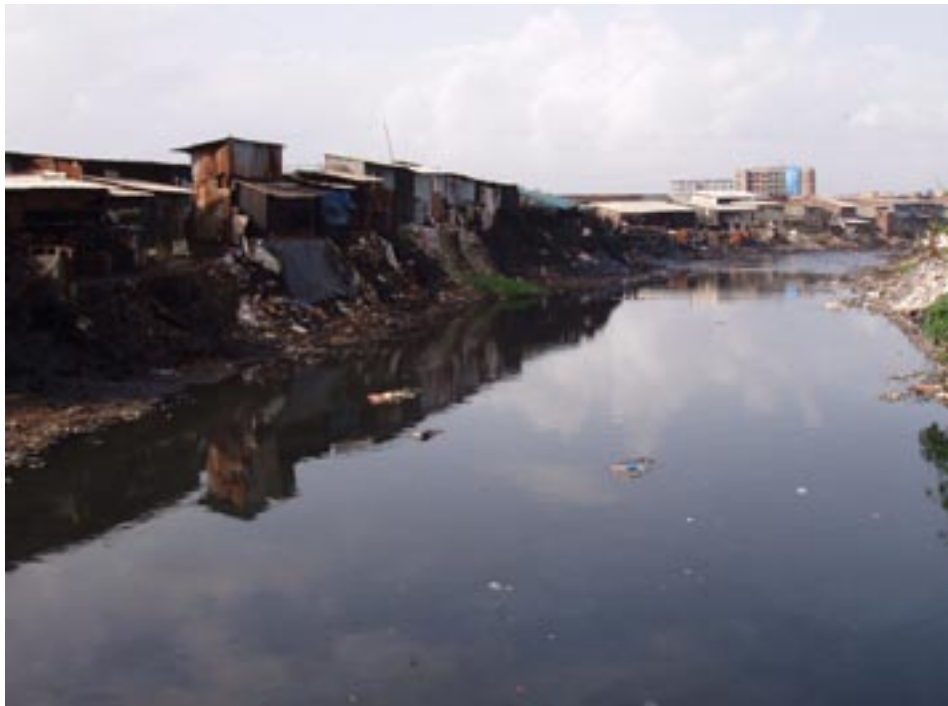
13 Oil Industry at Old Airport Road -1

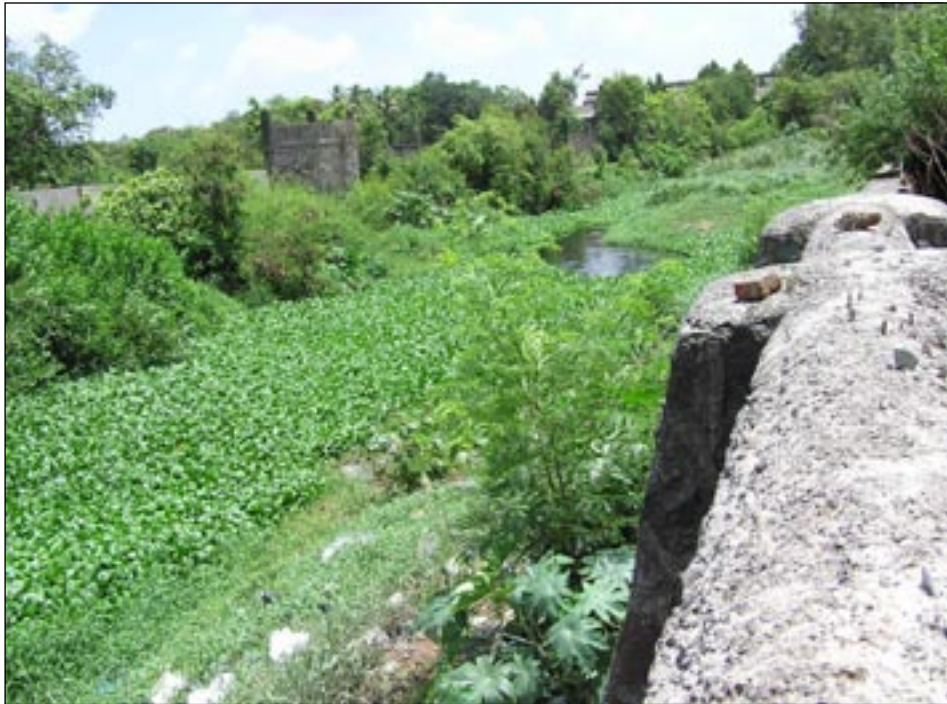
7)	Behind Samhita Complex Safed Pool.	This spot was surrounded by industrial are which has organized industries with probably small quantity discharge.

15 Samhita Complex, Andheri Kurla Road, Safed Pool - Note growth of Hyacinth and other vegetation.

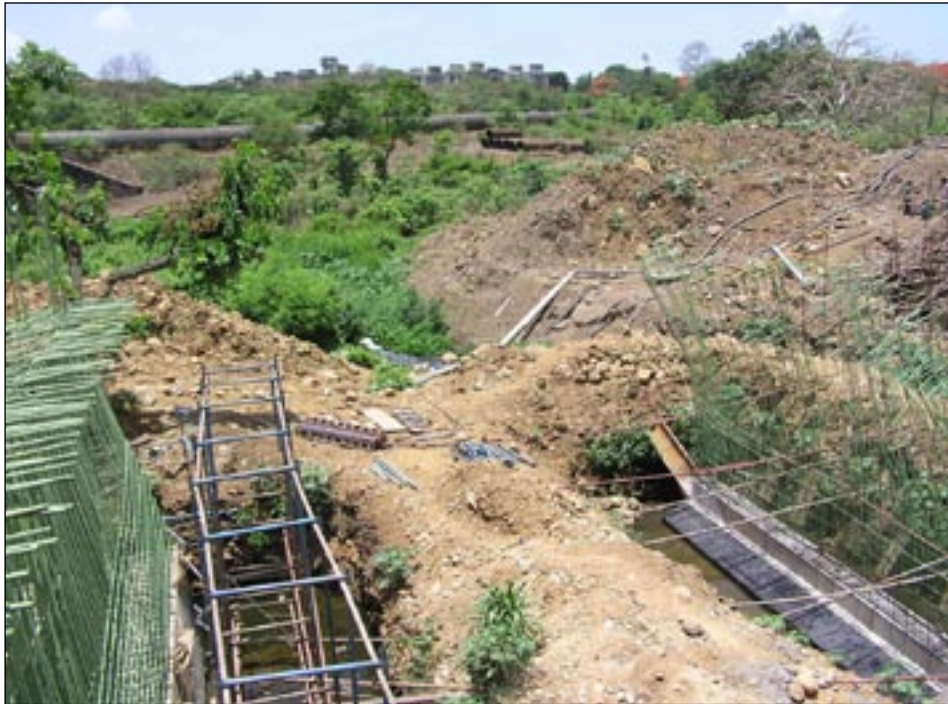
4)	Jogeshwari - Vikhroli Link Road	The first point on the down stream of river is surrounded by residential areas. The river at this point is being trailed under the newly constructed Jogeshwari - Vikhroli link road.

16 Vikhroli - Jogeshwari Link Road - River is reconstructed under new road.

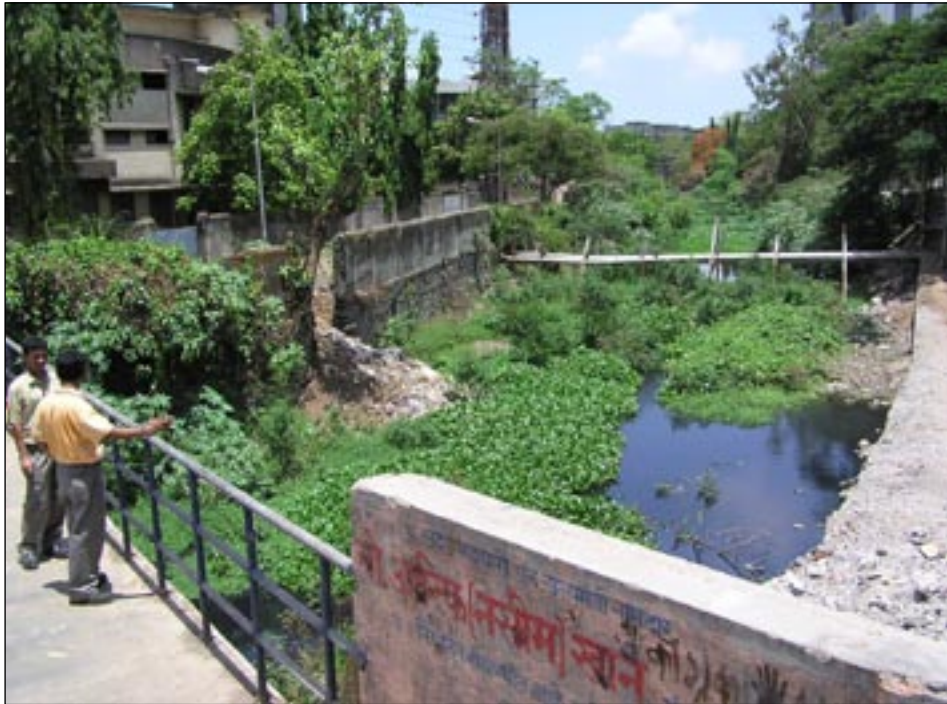
5)	Marvel Industrial Estate	The additional discharge to the river may be done to industrial effluent as indicated by COD load as well as oil & grease values.

17 Saki-Vihar Cross Road, Opp. Marve Industrial Estate - Indicating dumping of scrap materials and growth of vegetation.

- 3) Provide proper garbage collection system on both banks of the river, so that garbage is not dumped in the river.
- 4) To improve flow pattern, it is essential to clean the bed of Mithi river right from Powai to Mahim. This will improve its carrying capacity.

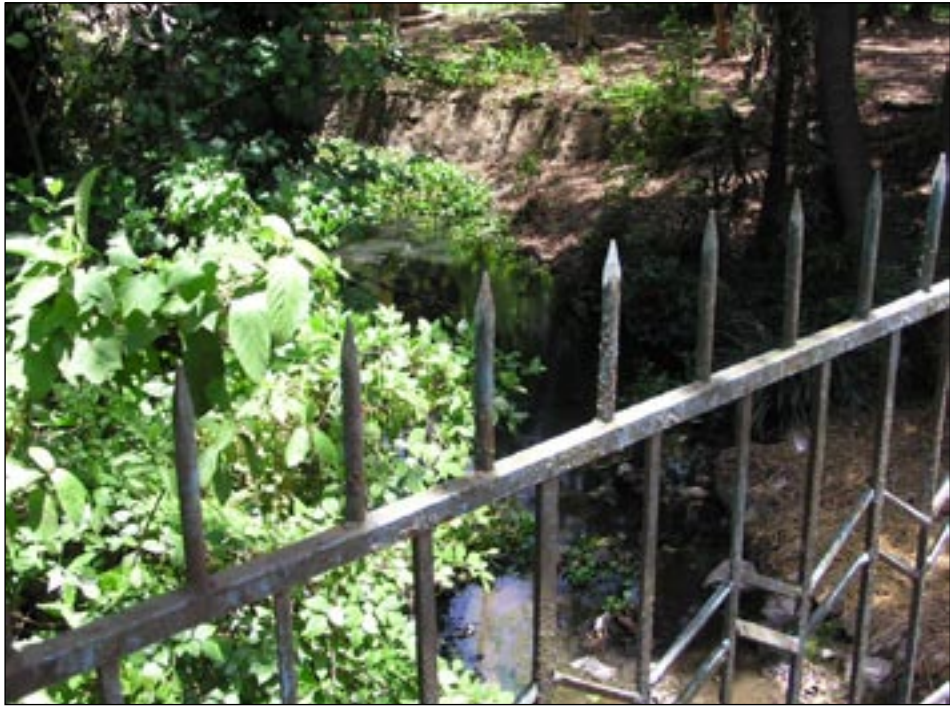
S. No.	Location	Description
1)	Powai Lake Overflow	The Powai lake overflow sampling point is in Ambedkar udyan adjoining Powai road.
2)	Mithi River origin	The location of origin of Mithi river is behind BMC water works office. The river is accessible and is full of hyacinth indicating sewage coming to the river from Vihar lake overflow.

18 Powai Lake Overflow near Ambedkar Garden.
